DEPARTMENT OF TRANSPORTATION

Quality Assurance and Source Inspection

Contract #: 04-0120F4Cty: SF/ALA Rte: 80 PM: 13.2/13.9File #: 69.15**SOURCE INSPECTION REPORT****Resident Engineer:**Pursell, Gary**Address:** 333 Burma Road**City:** Oakland, CA 94607**Report No:** SIR-000689**Date Inspected:** 19-Jun-2009**Project Name:** SAS Superstructure**OSM Arrival Time:** 0**Prime Contractor:** American Bridge/Fluor Enterprises, a JV**OSM Departure Time:** 12**Contractor:** Zhenhua Port Machinery Company, Ltd (ZPMC), Changxing Island **Location:** Changxing Dao, Shanghai

OBG Lift 2W

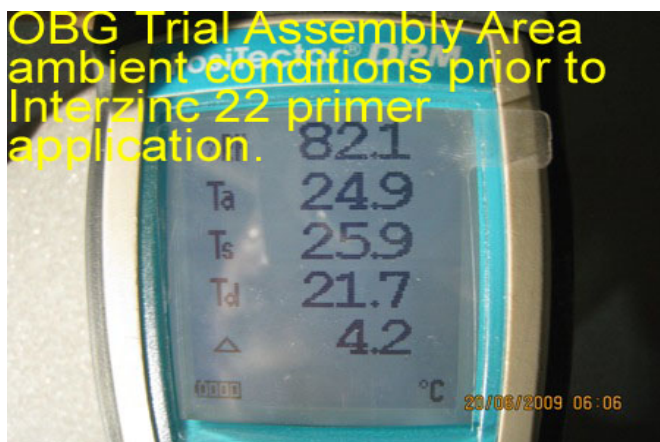
Caltrans QA Coatings Inspectors received Notices of Inspection to attend joint inspections with ABF and ZPMC QC for surface preparation by abrasive blasting and primer coat application on OBG L2W internal and external weld seam joint. Surface rusting was visible on the abrasive blasted areas. After looking at the abrasive blasted

surfaces it was pointed out to ABF QC personnel by Caltrans QA Coatings Inspector Jordan that the base metal did not meet the Society for Protective Coatings (SSPC) SP10 Near White Metal Contract requirements. ZPMC was informed by ABF QC that further abrasive blasting was required. The contractor began performing the repairs as directed by ABF QC personnel.
